ESL-TR-91-13
VOL II

**EXPEDIENT REPAIR OF STRUCTURAL
FACILITIES (ERSF) - VOLUME II: ERSF
SYSTEM REQUIREMENTS AND USERS
GUIDE**

**APPLIED RESEARCH ASSOCIATES, INC.
P. O. BOX 40128
TYNDALL AFB FL 32403**

JULY 1991

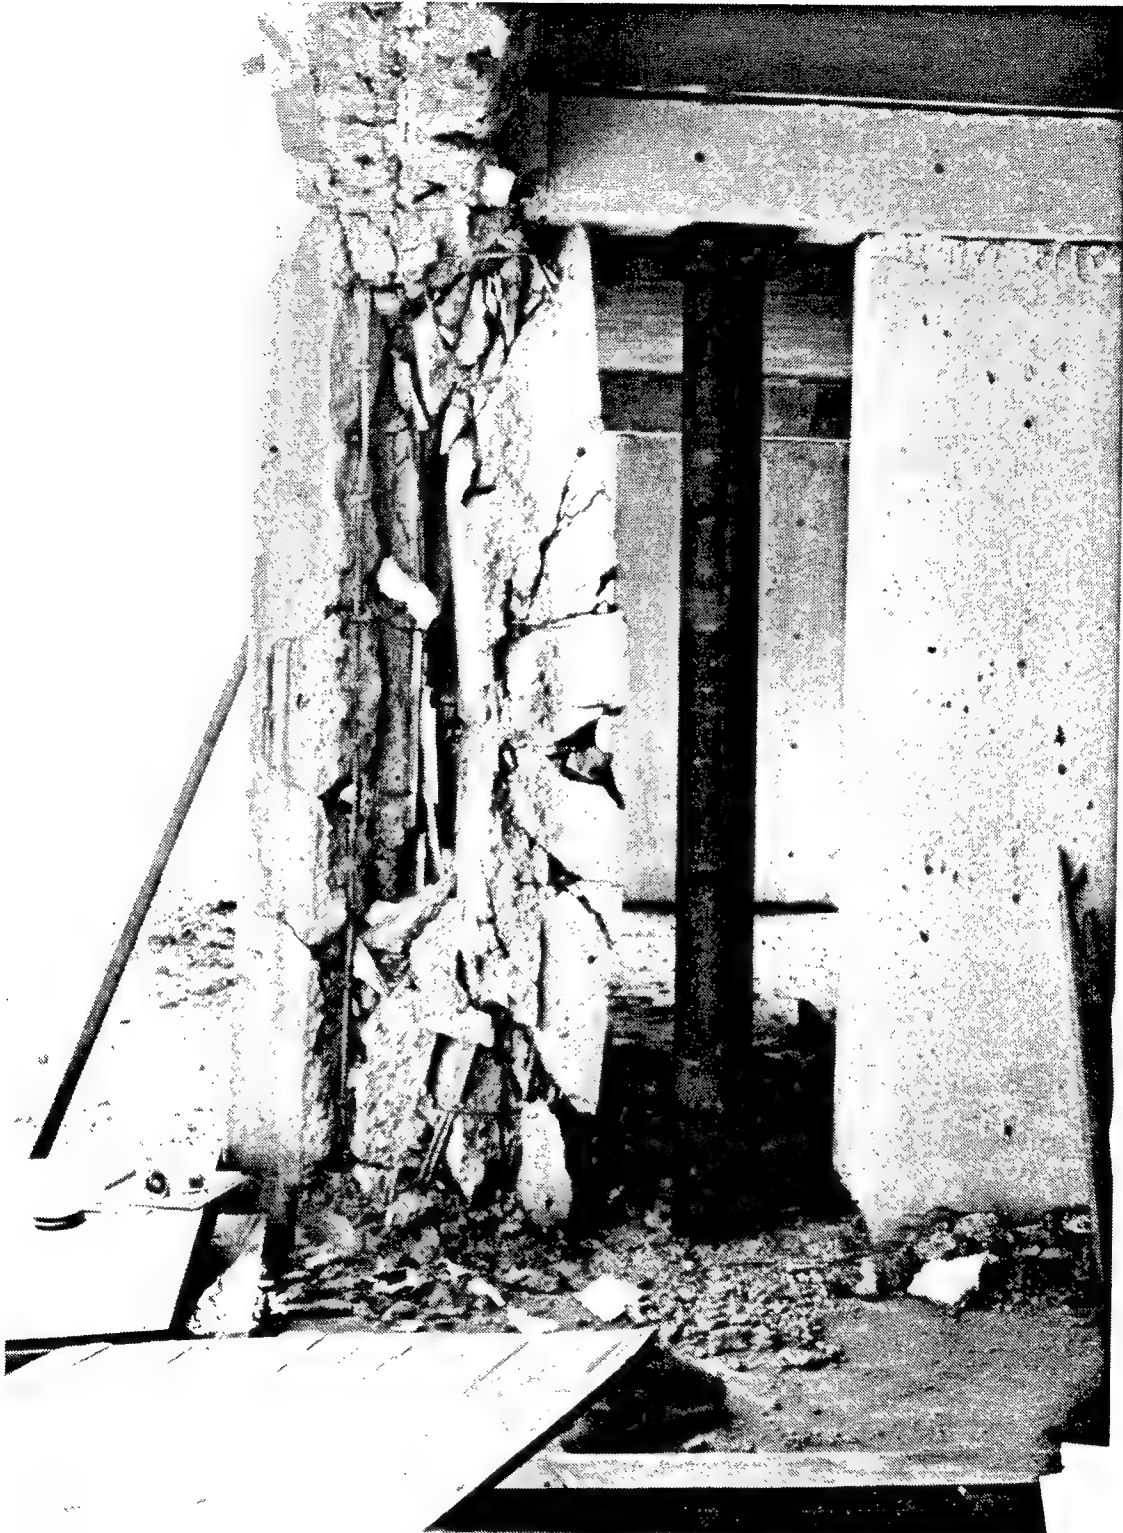
Figure 1. Example of a Destroyed Column.

In this damage mode, a reinforced concrete column is damaged by blast and/or fragments, to the extent that it can no longer support its design load and must be replaced. An example of such a damaged column is shown in Figure 1. Candidate column replacement ERSF systems are described below.

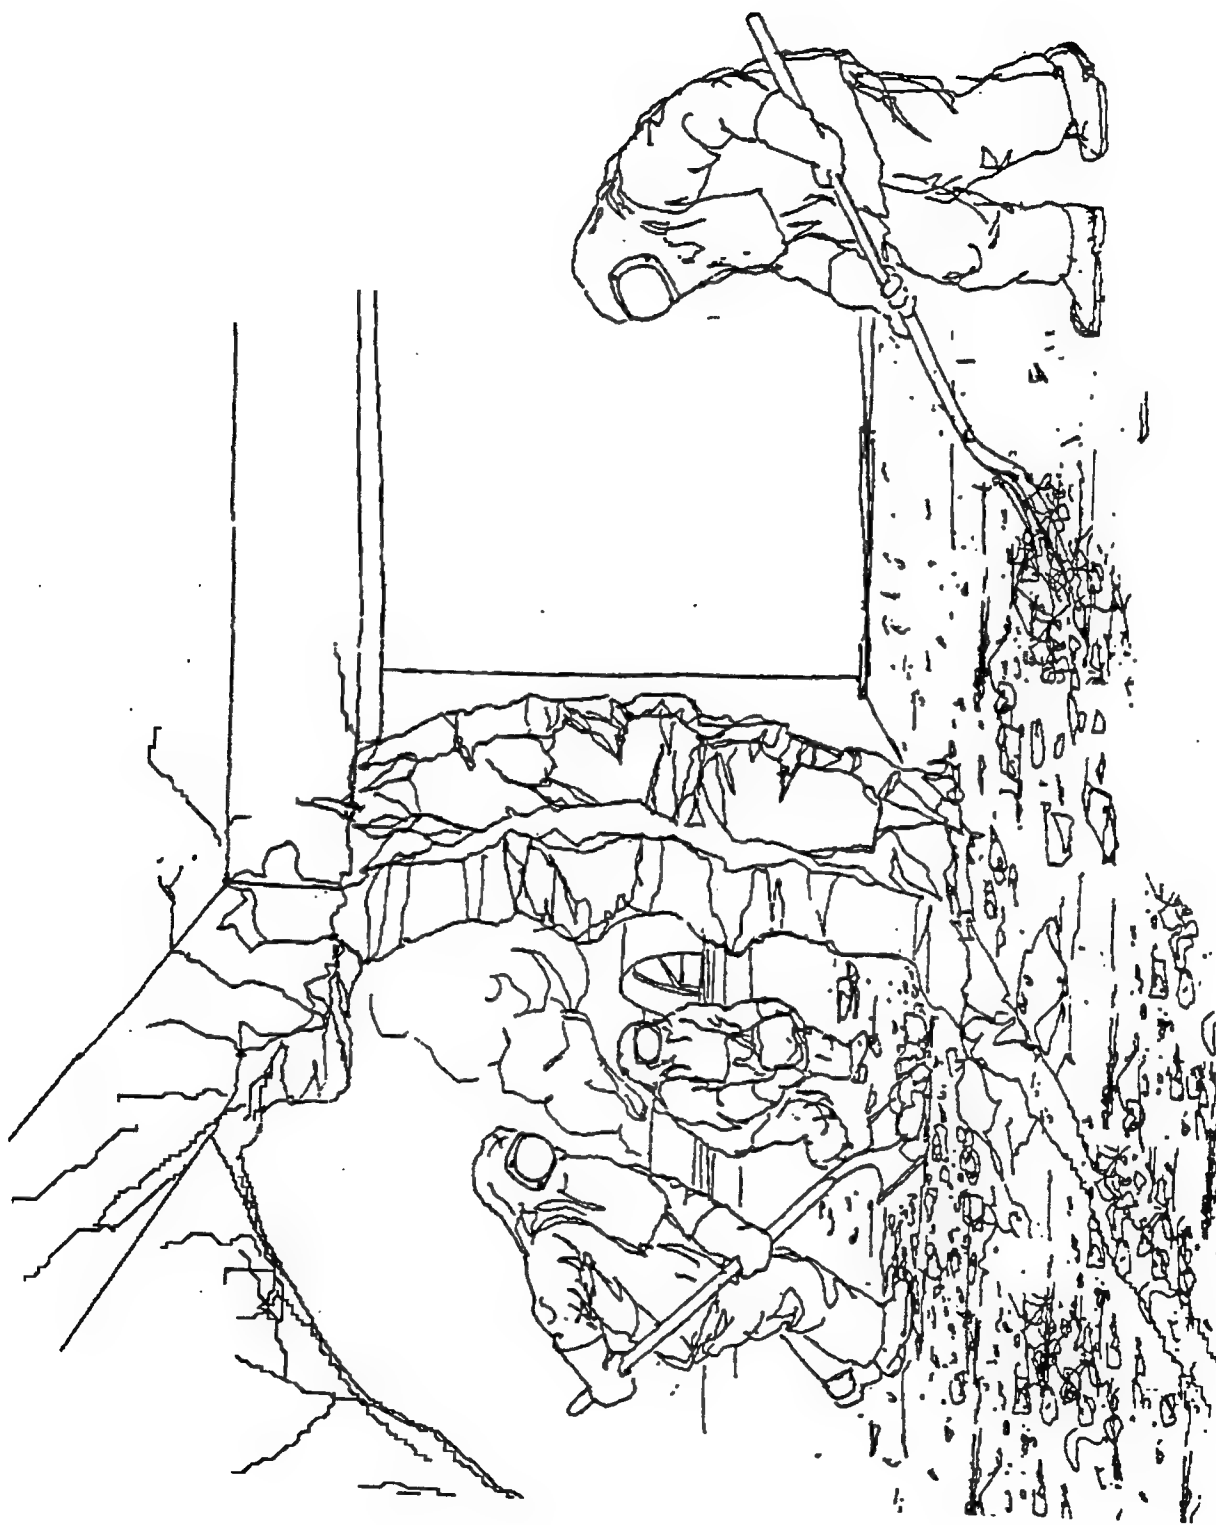
Figure 2. Debris Clearance During Column Replacement.

Figures 2 through 5 show a method for replacing a badly damaged reinforced concrete column. After clearing away debris and other interfering, non-load-bearing structural material from around the column, a shoring jack is placed beside the damaged column, then extended until its capacity is reached or repair personnel can no longer extend it, whichever occurs first. Then a glued, laminated timber (glulam) column, trimmed to the correct length, is positioned and wedged next to the jack. A 10-foot long, 12-inch square glulam column should provide sufficient capacity, while still being relatively easy to handle. The capacity of such a column is discussed in Section VI. The glulam column is braced laterally with lumber for stability, and the jack removed to be reused elsewhere, leaving the glulam column to carry the vertical load.

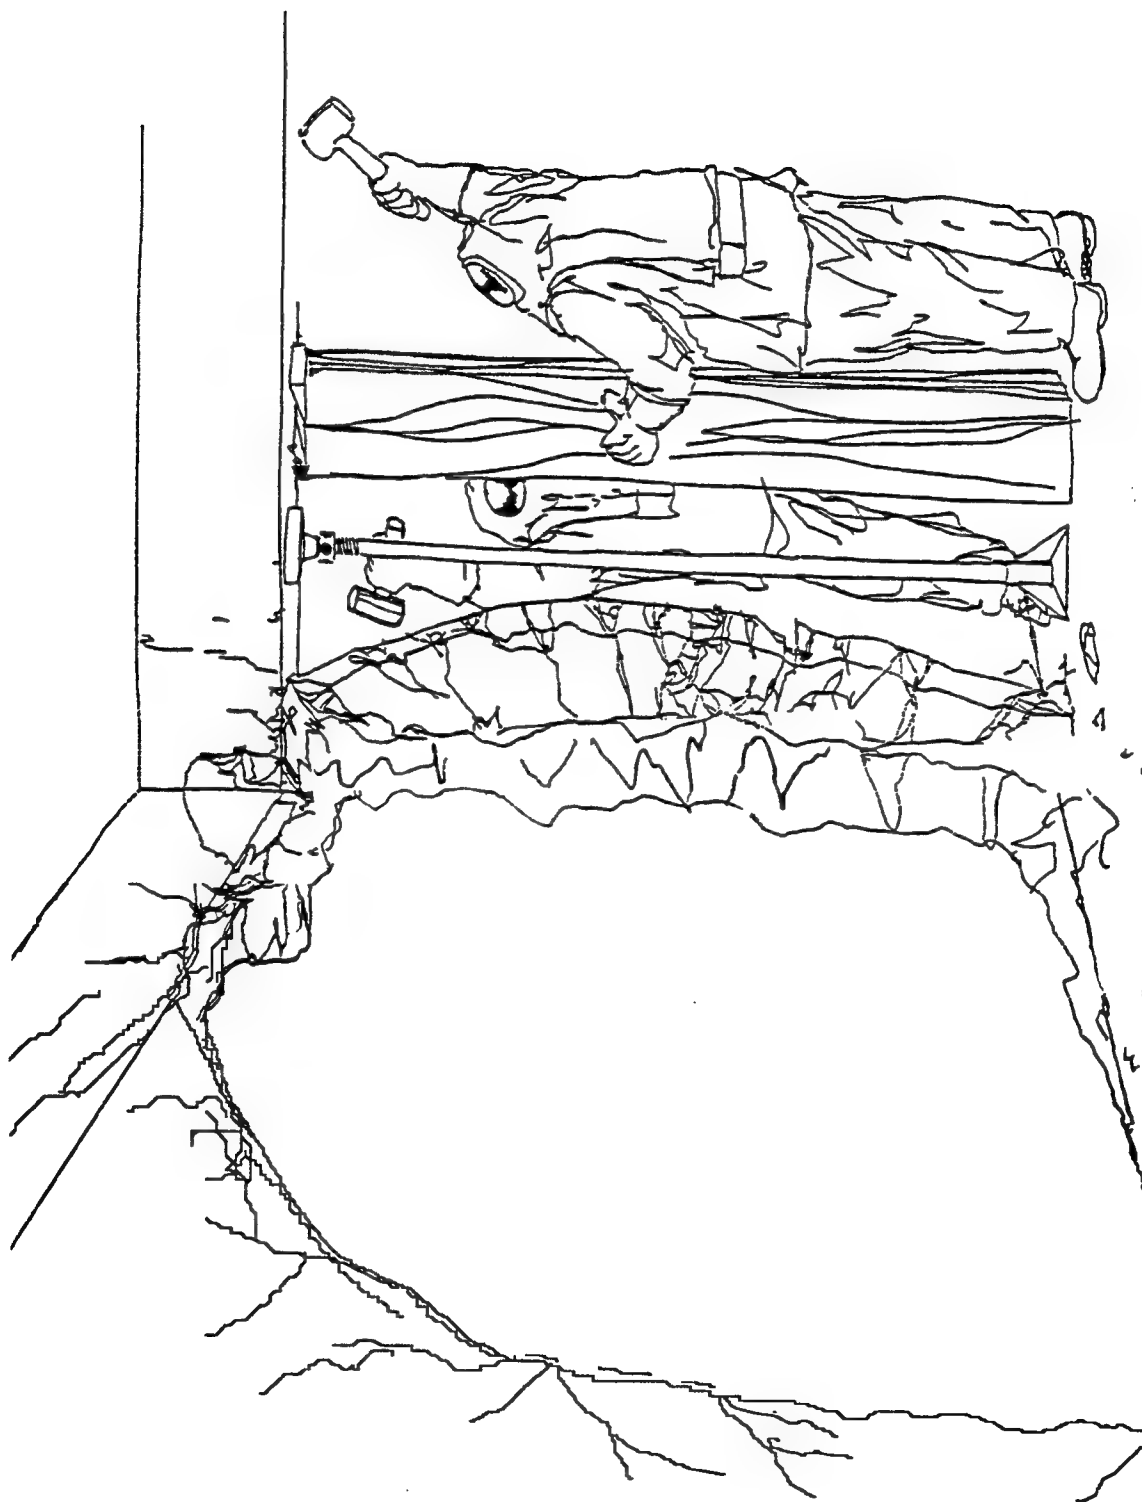
Figure 4. Column Insertion During Column Replacement.

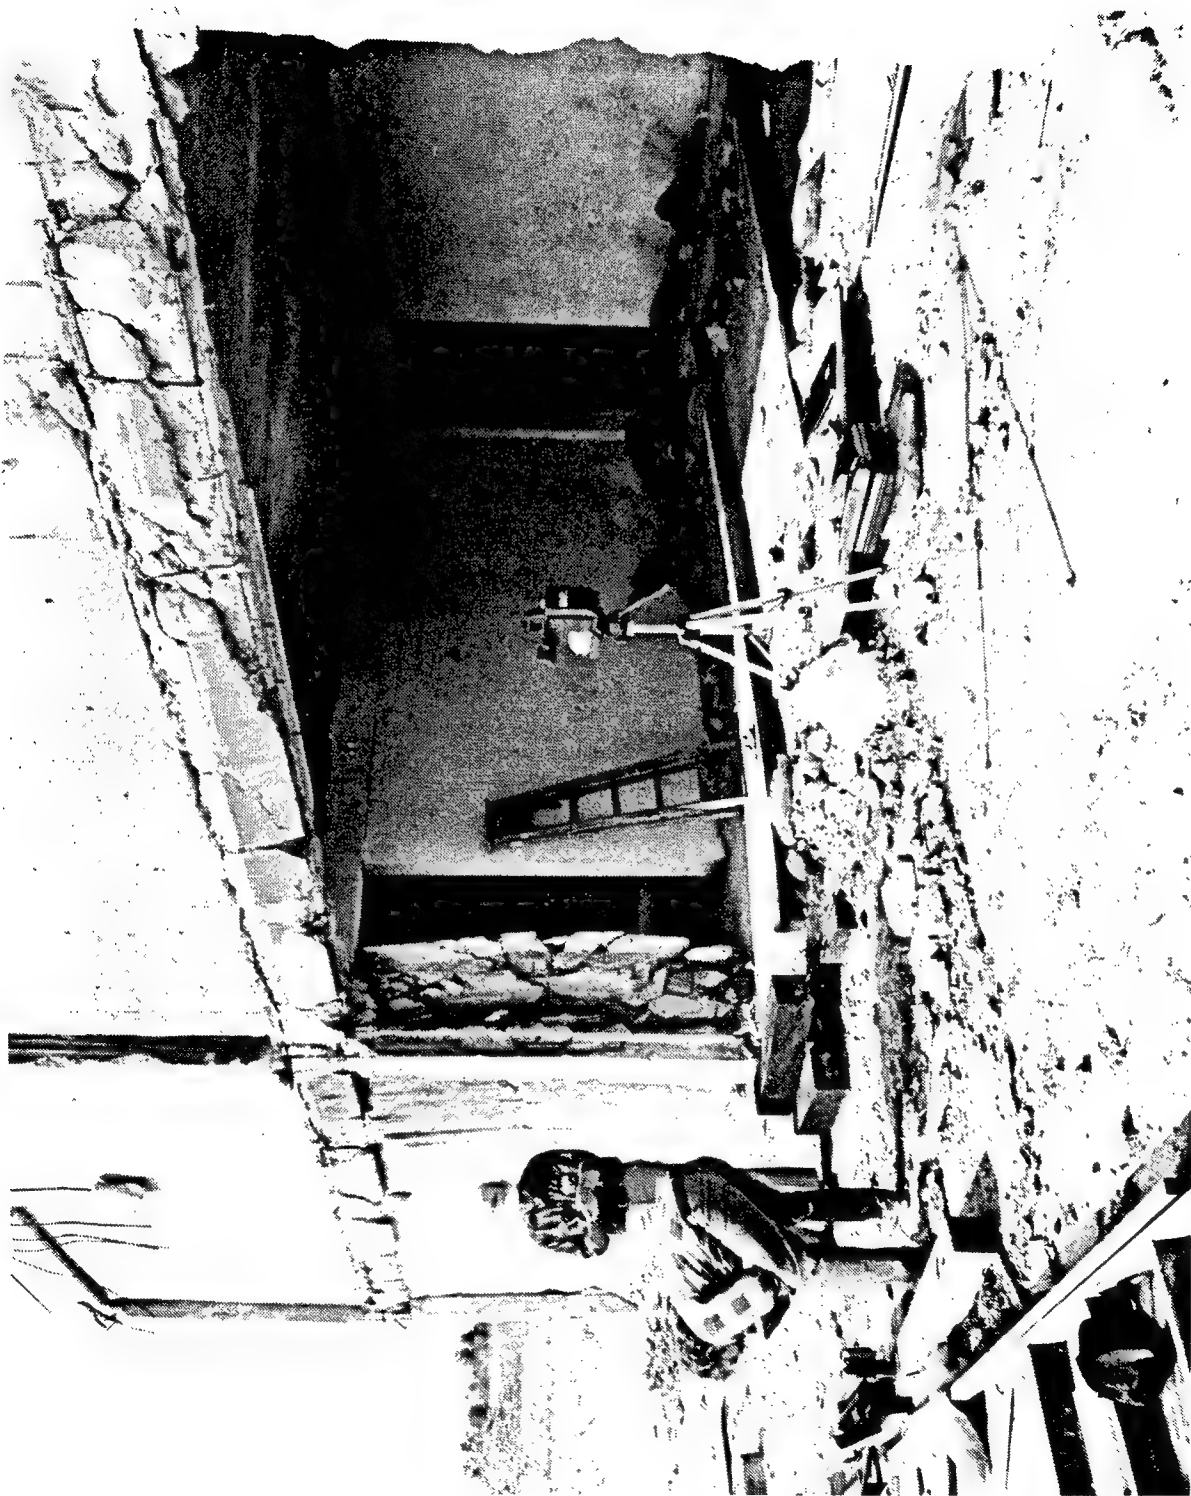
Figure 11. Damaged Reinforced Concrete Beam/Girder.

In this damage mode, a reinforced concrete girder/beam is fractured, but still capable of carrying a reduced load. An example of this damage mode is shown in Figure 11. The beam's load-carrying ability can be increased by using a vertical shore, similar to a column replacement repair, or by the king post device shown in Figure 12. The disadvantages of the king post are the high tensile forces in the rods (essentially the bottom chords of a simple truss), and the difficulty in securely anchoring the rods at both ends of the damaged beam. However, when other structural damage precludes using a vertical shore, a king post may be the only alternative.

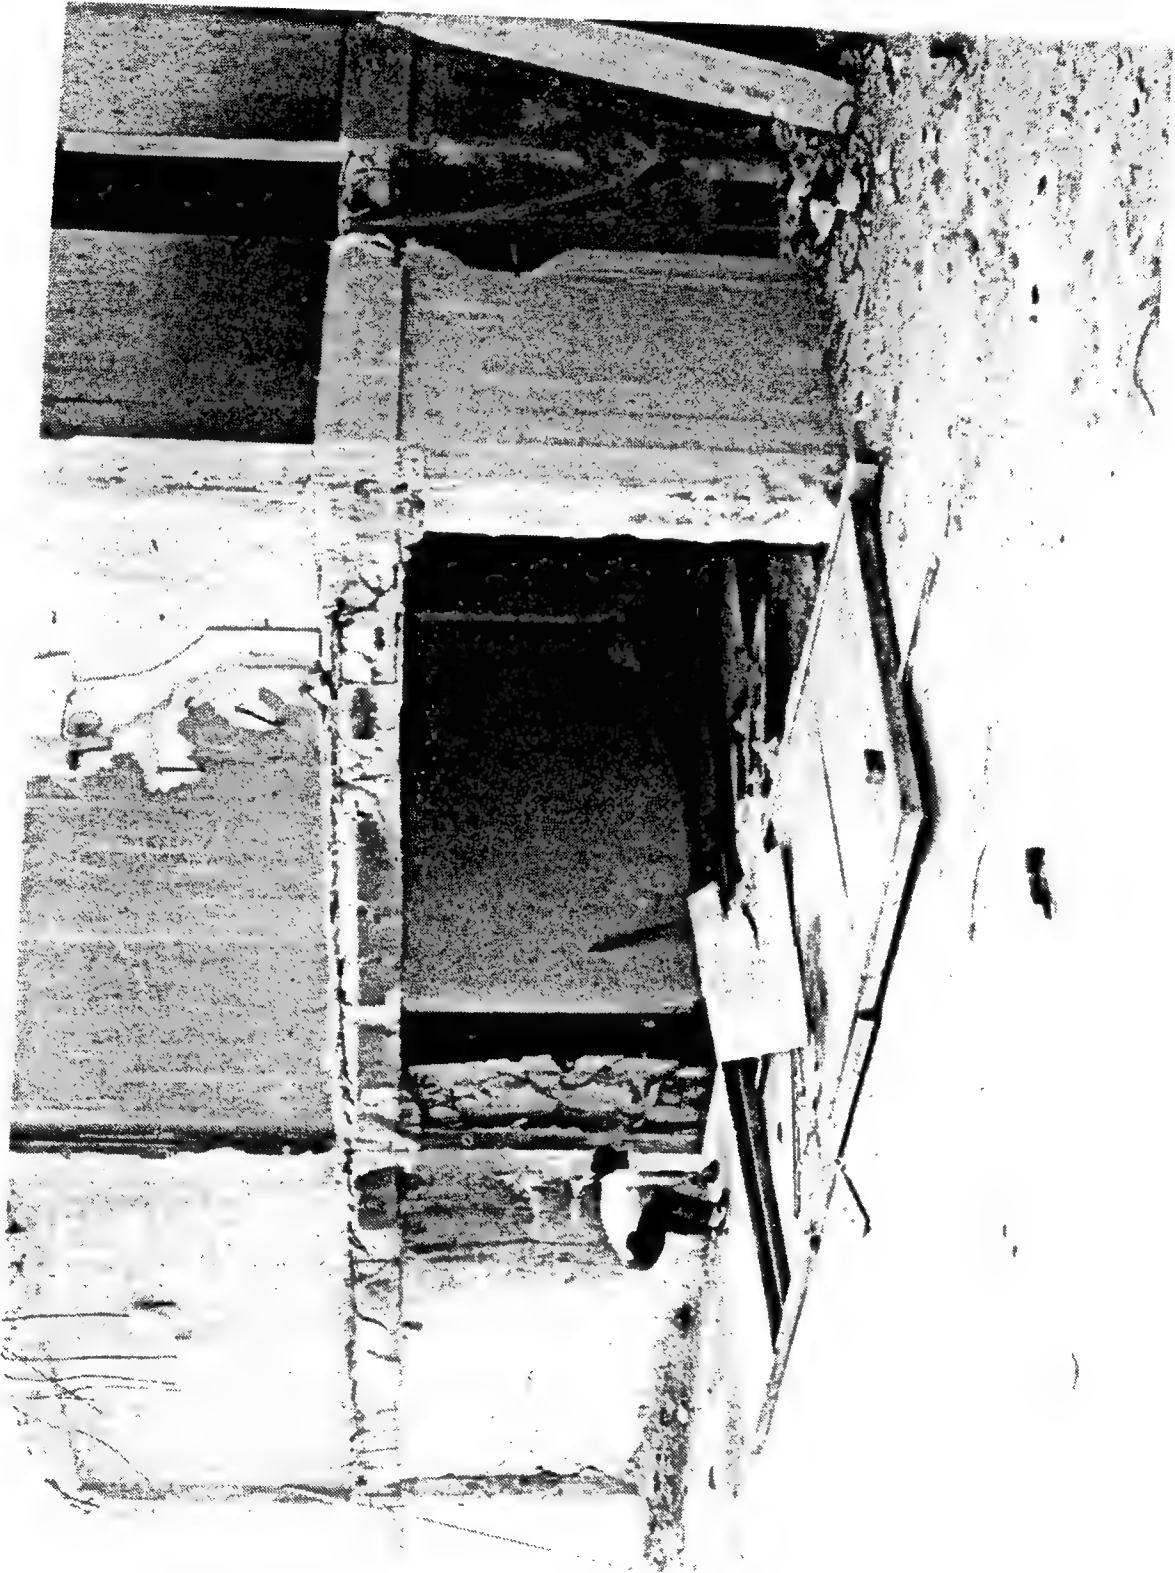
Figure 14. Destroyed Reinforced Concrete Wall.

In this damage mode, a non-load-bearing, reinforced concrete or masonry block wall has been completely destroyed, with only minimal portions of the wall remaining attached to the surrounding columns and floor or roof beams. An example of such a wall is shown in Figure 14. Candidate expedient repair methods for such a damage mode are described below.

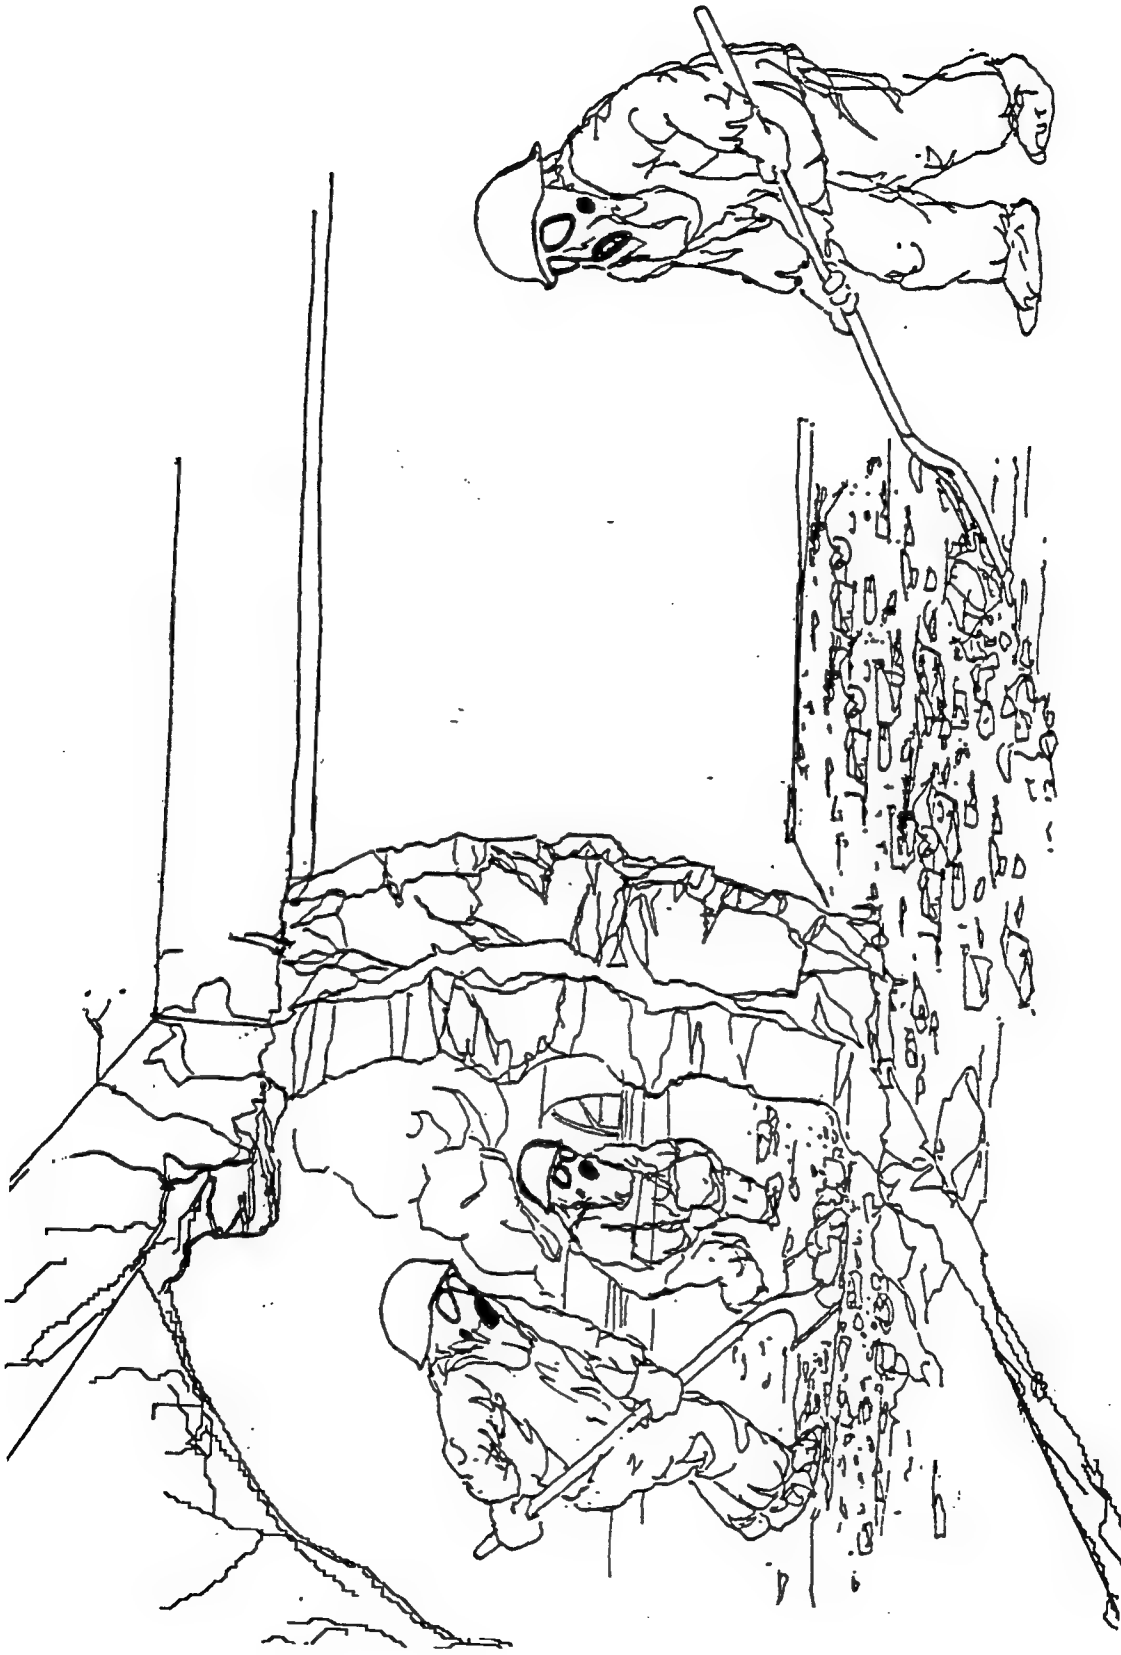
Figure 15. Debris Clearance During Shotcrete Wall Replacement.

In this repair, a rapid-setting, high-strength, steel-fiber-reinforced, dry-mixed shotcrete material developed by AFESC/RD's materials branch (AFESC/RDCM) is used to replace the destroyed wall as shown in concept in Figures 15 through 17. Development of this material is described in Reference 18. A general discussion of shotcrete, including expedient repair concepts with the material, are given in Reference 19.

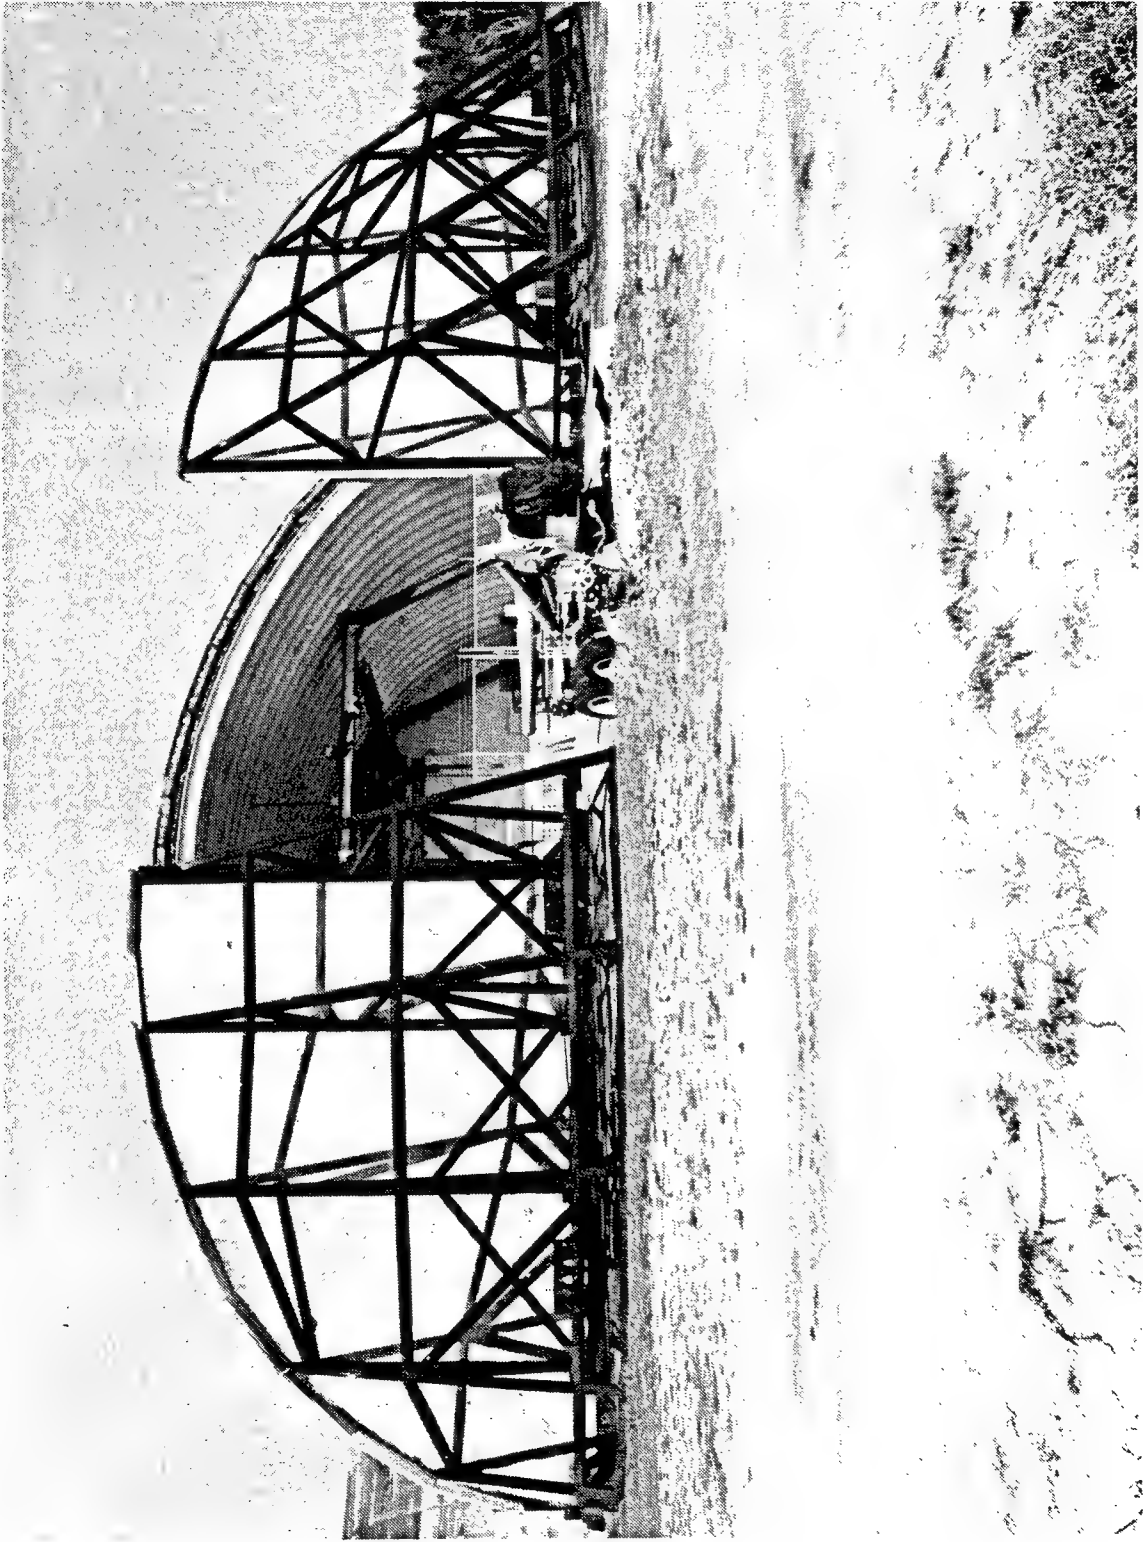
Figure 24. Third Generation Aircraft Shelter's Blast Door.

In this damage mode, a third generation aircraft shelter's blast door (see Figure 24) has been warped by blast effects from a nearby weapon detonation, and will not slide open freely. The goal of expedient repair in this circumstance is to force the door open, so the aircraft inside the shelter can be removed. It is not the intent of the expedient repair to allow the door to be opened and closed again in a normal manner. Consequently, the repair will consist of attaching heavy equipment, such as bulldozers with chains and shackles, to both sections of the door, and prying the door open enough to extract the aircraft. This repair is illustrated in Figure 25.

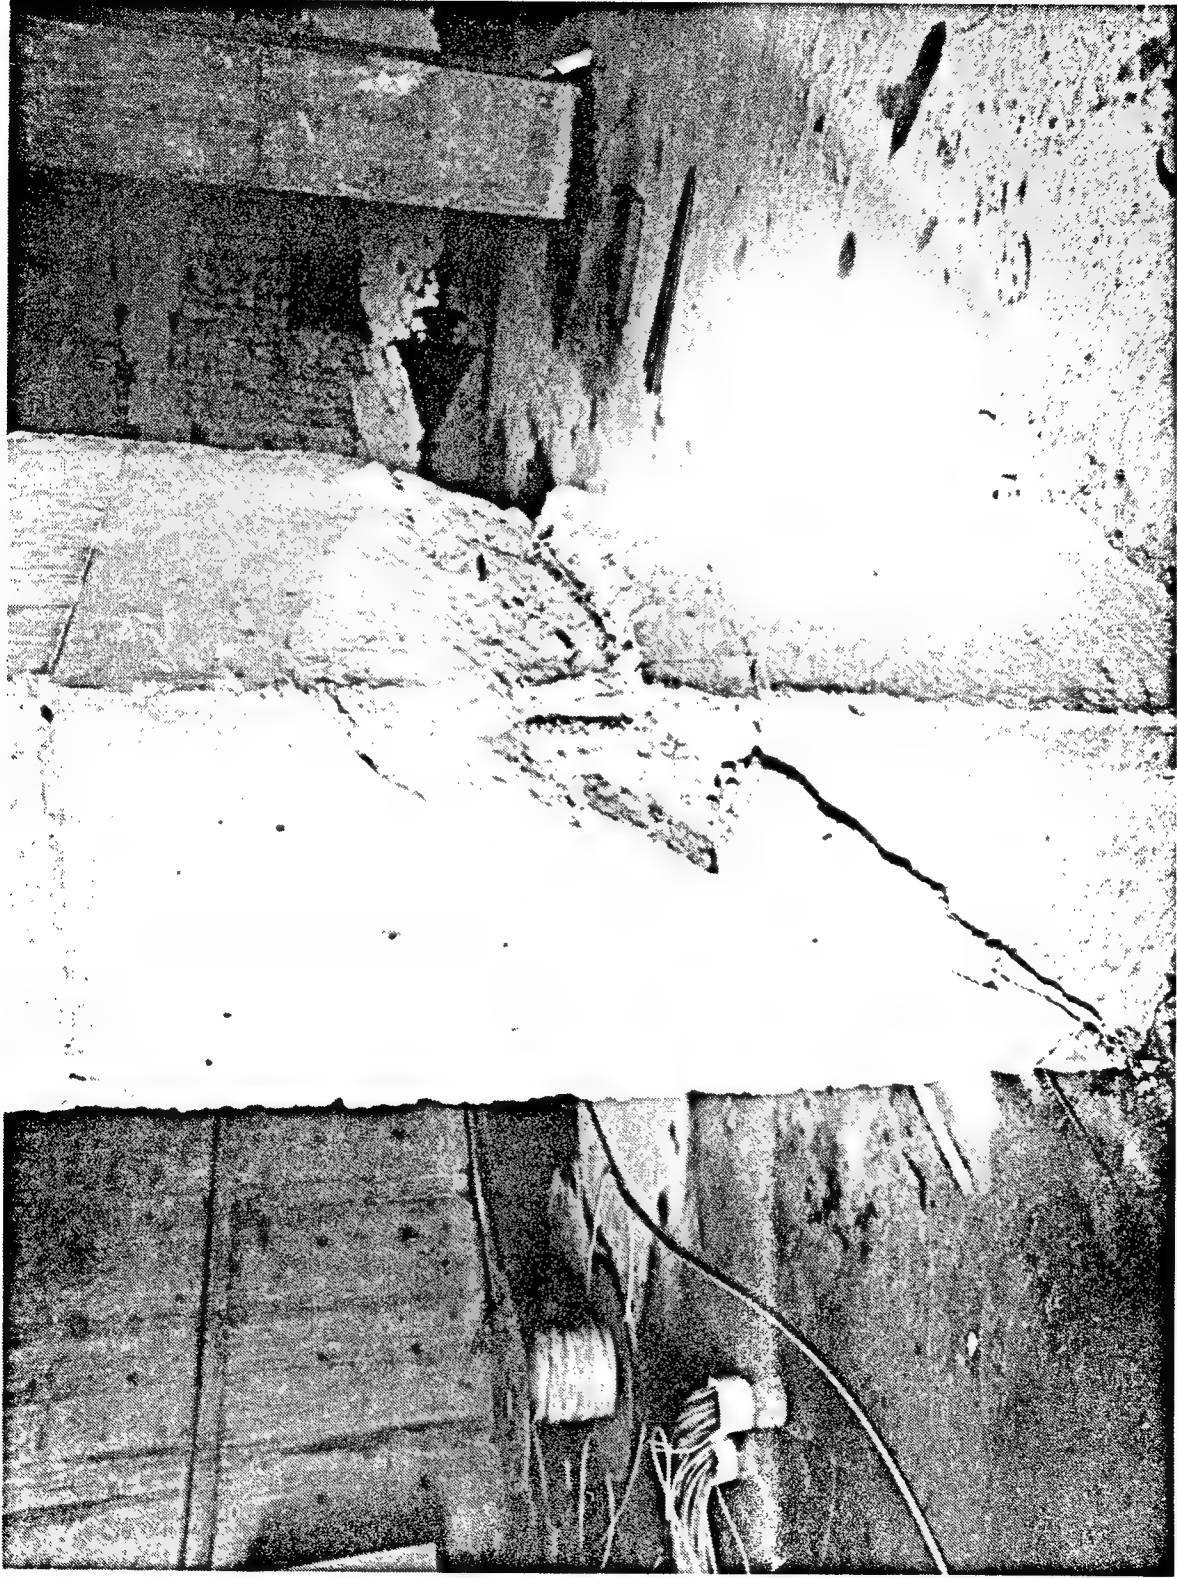
Figure 36. Cracked Concrete Column Used for the Column Splint
Field Demonstration.

On 23 February 1990 at the NATO structure, located at the SKY TEN explosive test area, Tyndall AFB, Florida, AFESC/RDCS conducted a field evaluation/demonstration of the ERSF column splint system. The demonstration was done using the cracked, 22-inch square reinforced concrete column of the NATO structure, shown in Figure 36.

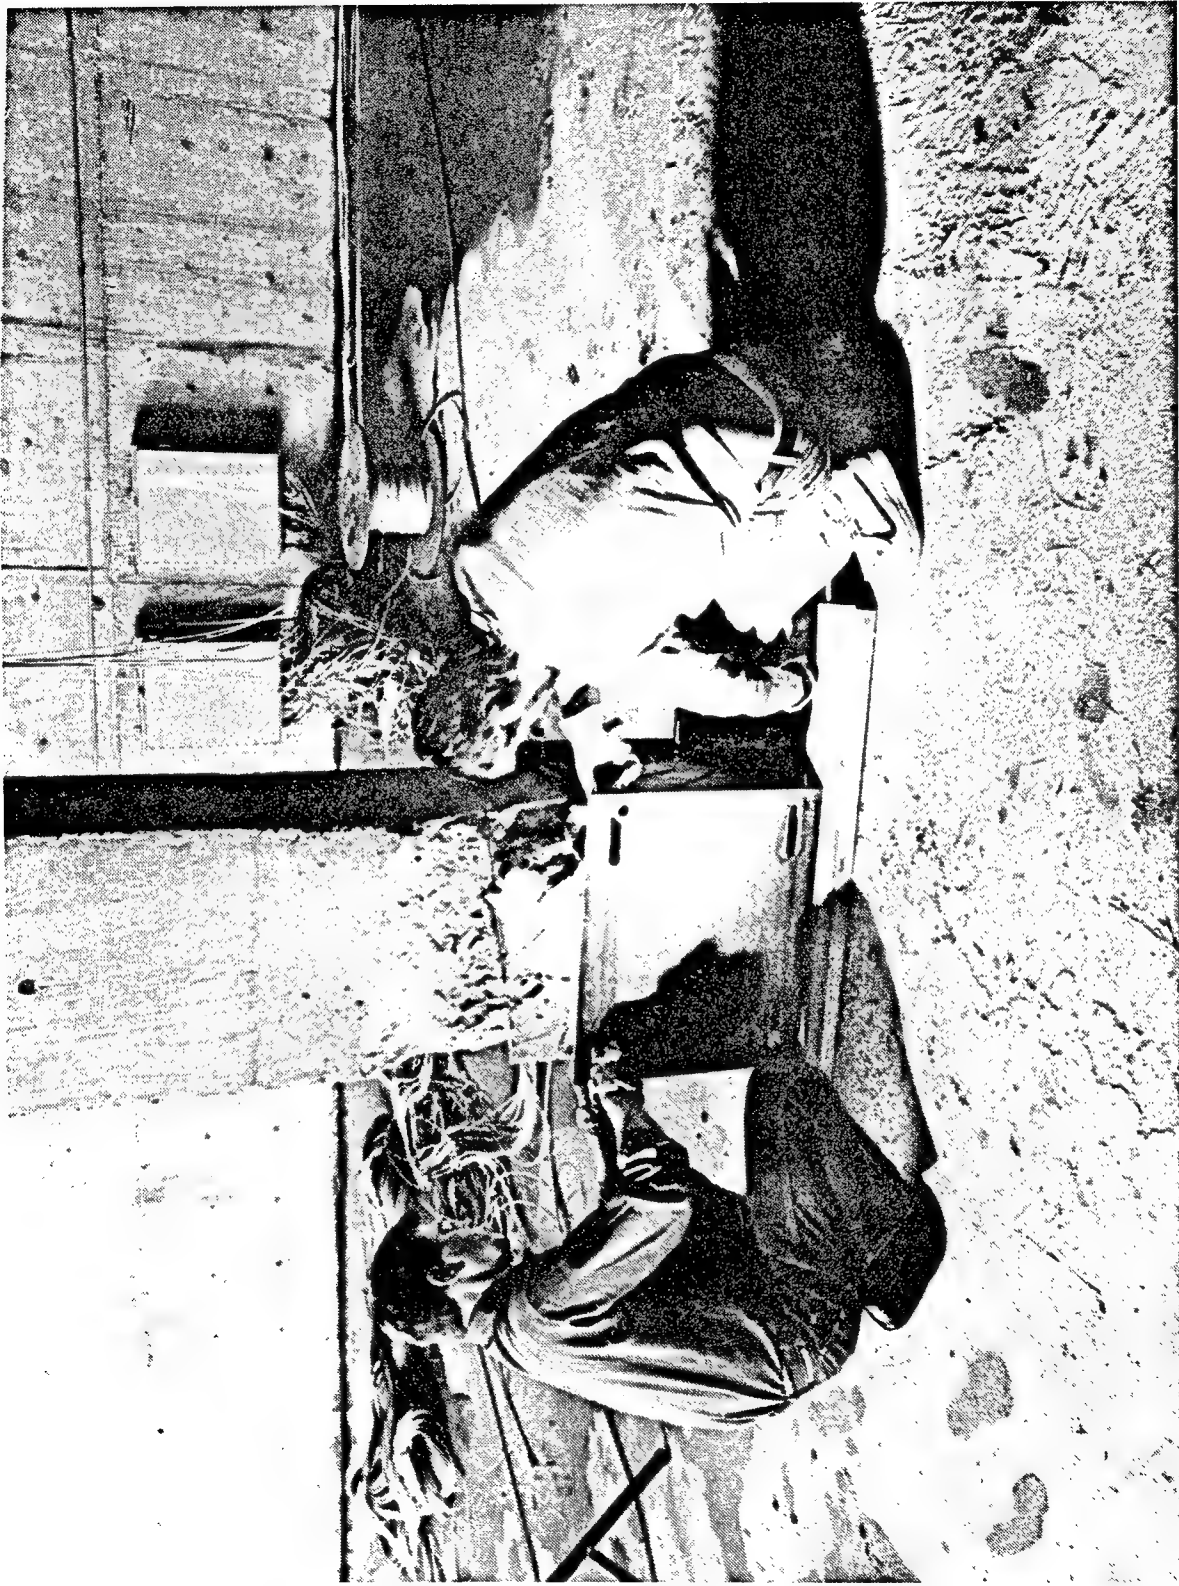
Figure 37. Positioning Splint Plates at the Bottom of the Column.

In general, the splinting process was accomplished as follows. The splint plates, with chains preattached to one plate with nuts and bolts, were positioned at the correct height on the column, as shown in Figure 37 (bottom of column) and Figure 38 (4 feet high on column). At the 4-foot height, rope was used to bind the two-by-fours to two sides of the column. The chains were then connected to the other plate with nuts and bolts, as shown in Figure 39, then tightened to clamp both plates to the column. The chain tightening process is shown in Figure 40.

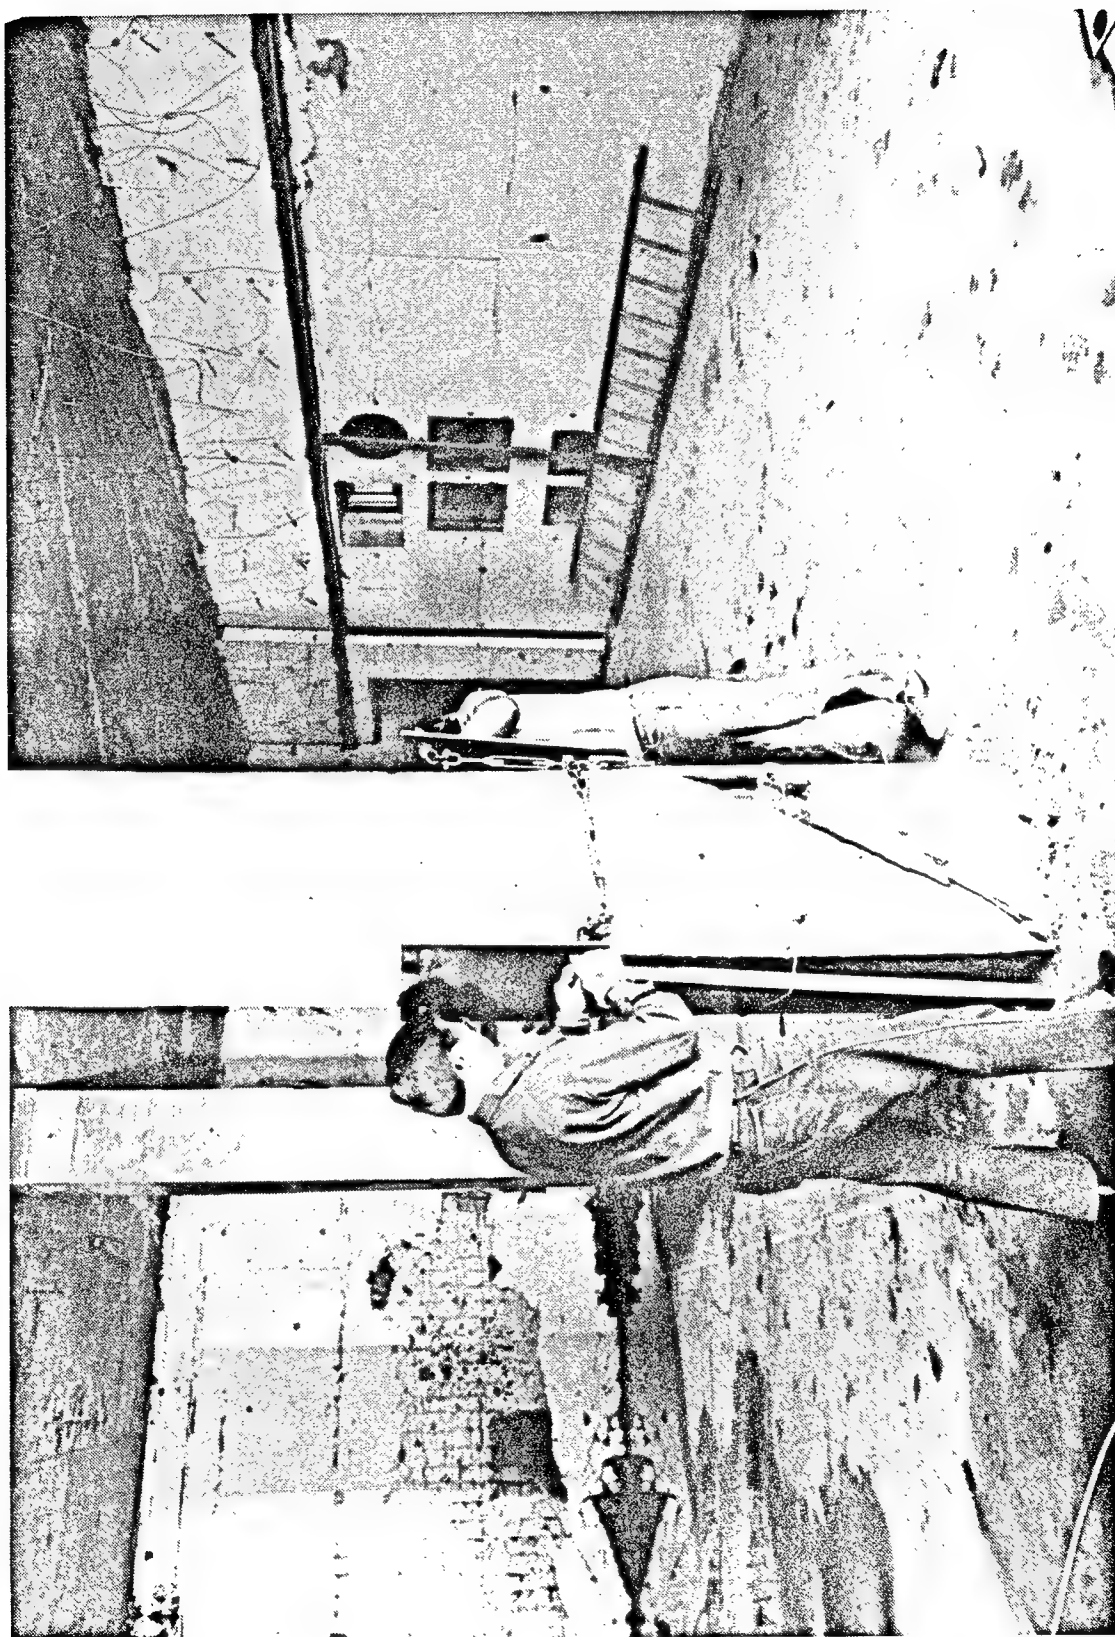
Figure 38. Positioning Splint Plates 4 Feet High On the Column.

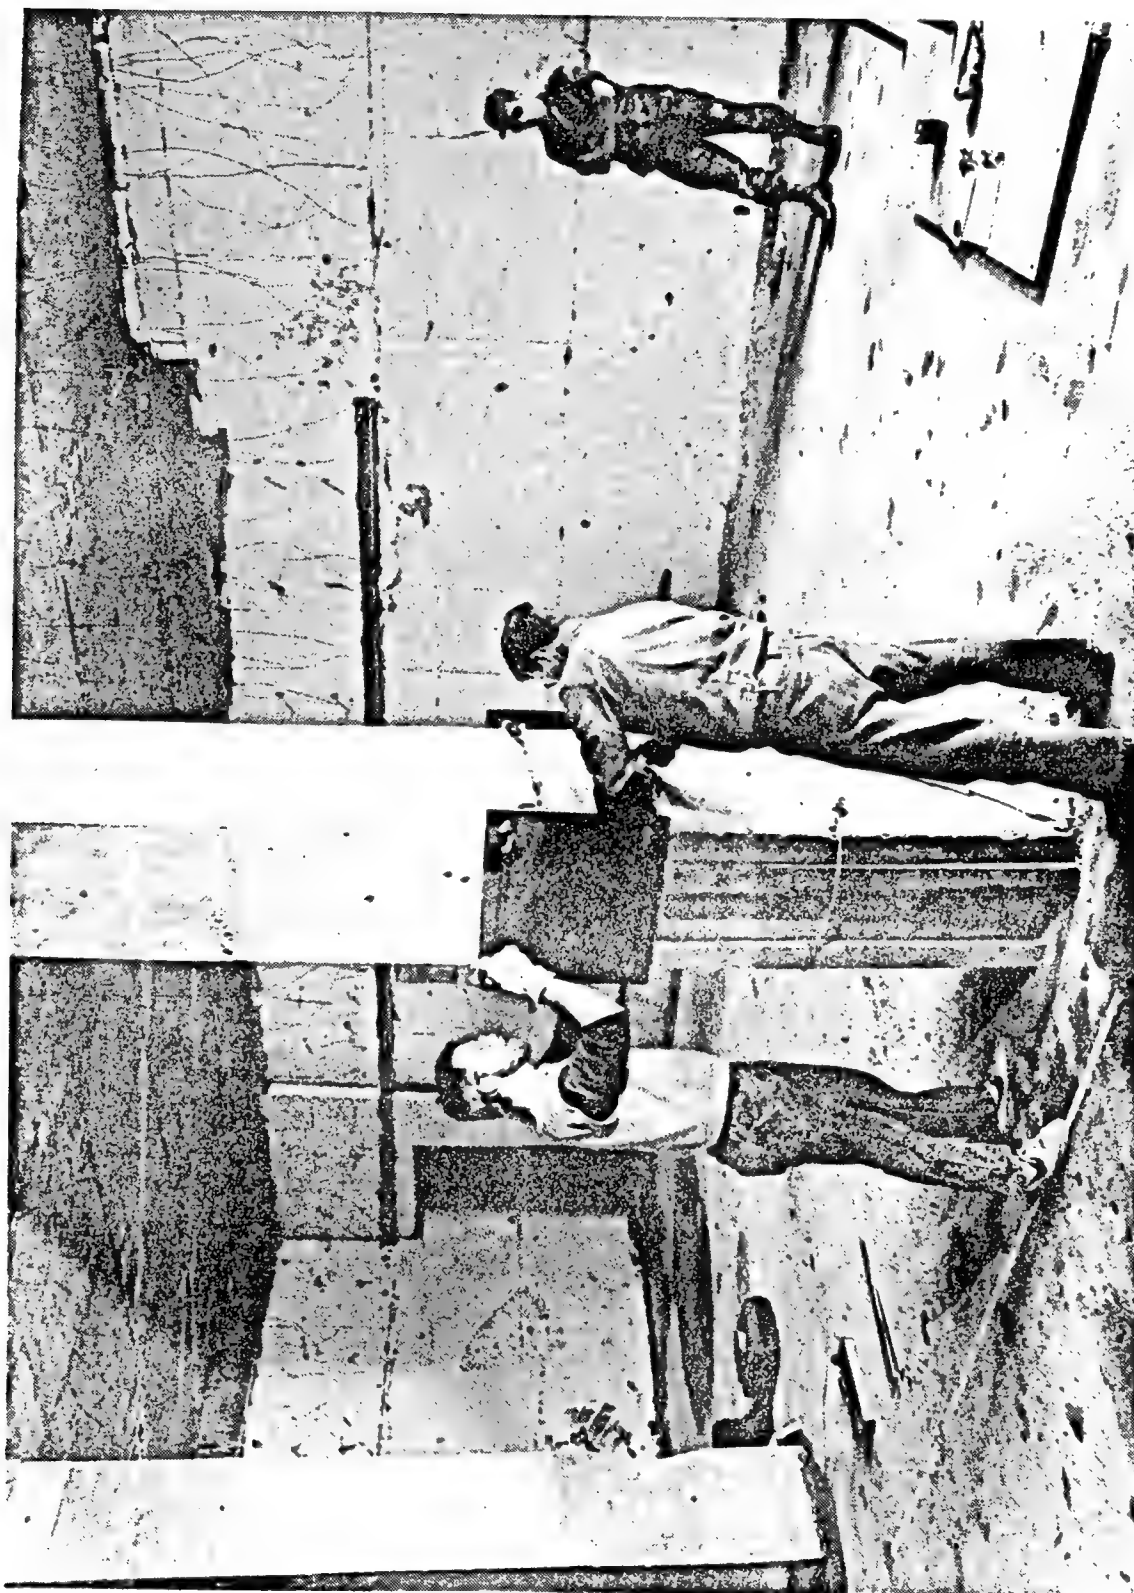
Figure 40. Tightening Splint Chains Around the Column.
